Ancient Forts, Modern Methods: Evaluating the Redesigned Mortar of Ramkot Fort Azad Kashmir

F.A. Ahmad¹, H. Waheed², D. Sajjad³, M.Z.U.R. Awan⁴, A. Khatib⁵

Department of Civil Engineering

Mirpur University of Science & Technology (MUST) Mirpur (AJ&K) Pakistan

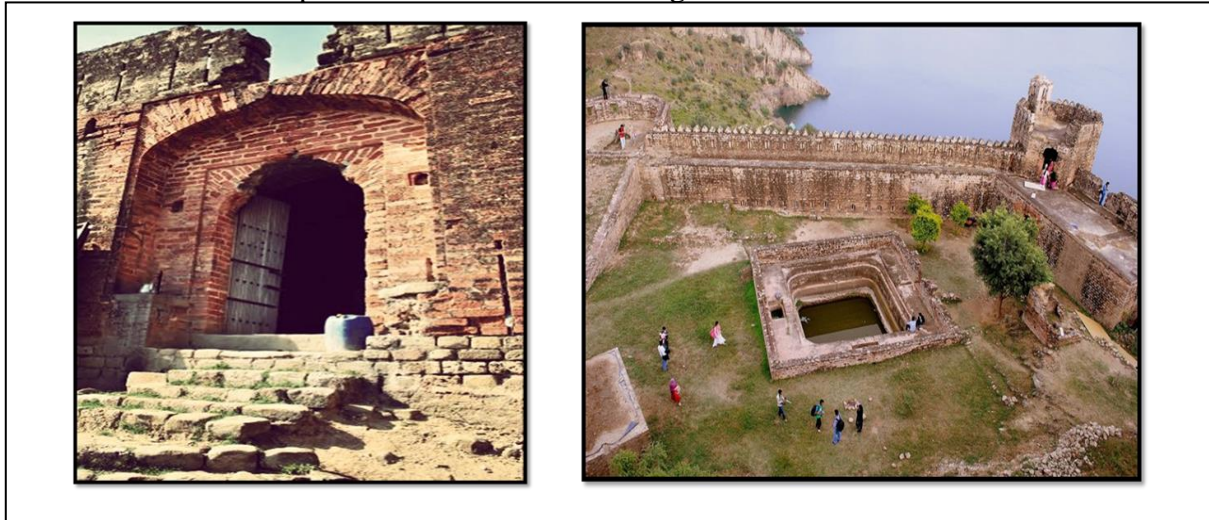
Figure 1: Ramkot Fort Azad Kashmir Pakistan

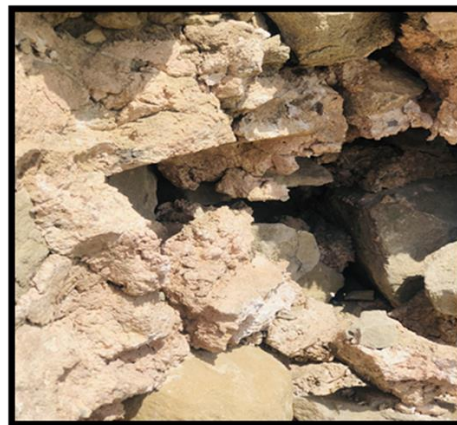
Figure 2 Deterioration of stone masonry of Ramkot Fort

Ramkot Fort holds significant historical value, representing various eras of regional history, including the Ghaznavid, Ghurid, Mughal, Sikh, and British periods. Preserving it helps maintain a tangible link to these past civilizations and their architectural styles. Rehabilitation of historic places is practiced safeguarding their historical, cultural, and architectural significance, ensure safety, and promote educational and tourism opportunities. As the fort has deteriorated with age, as shown in Figure 2, preservation efforts are urgently needed.

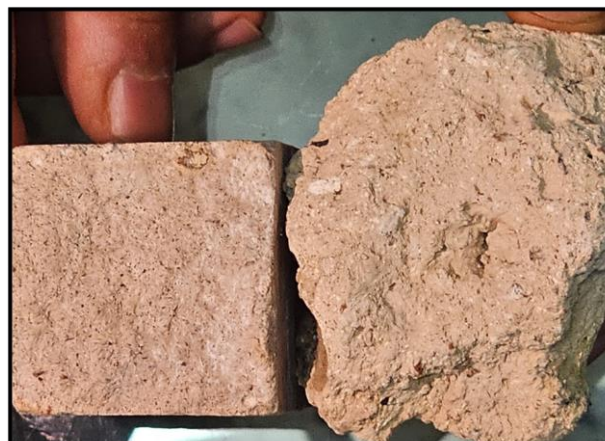
Figure 4: Comparison of old mortar (right) and modern mortar (left)

The materials used for the mortar mix, including lime, clay, red brick powder, and sand, are shown in Figure 3. The mortar was cast, and the prepared mortar and the historic mortar are compared in Figure 4.

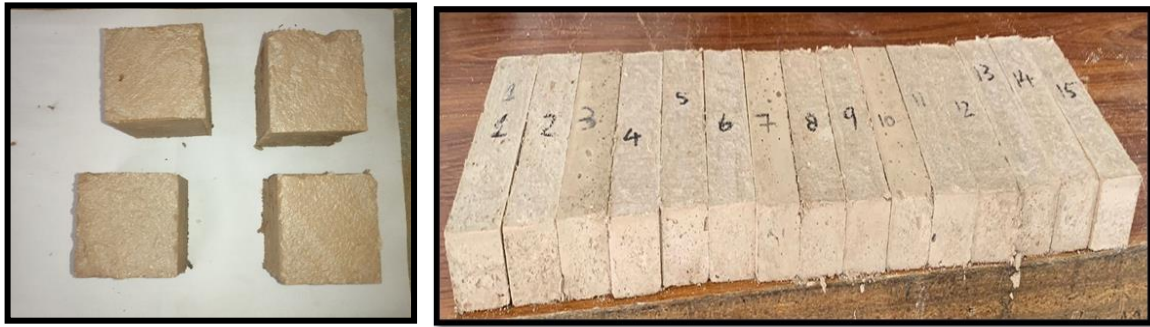
Figure 5 Prepared cubes (on left) and prisms (on right)

Mortar cubes and prisms were cast, which are shown in Figure 5. The newly designed mortar was evaluated in terms of physical and mechanical properties. The flowability was measured by ASTM C1437-20 method [4]. The density was determined through ASTM C188-17 method [5]. The compressive strength was measured through compressive strength by ASTM C1314-21 method [6], and the water absorption was examined through ASTM C1403-15 [7].

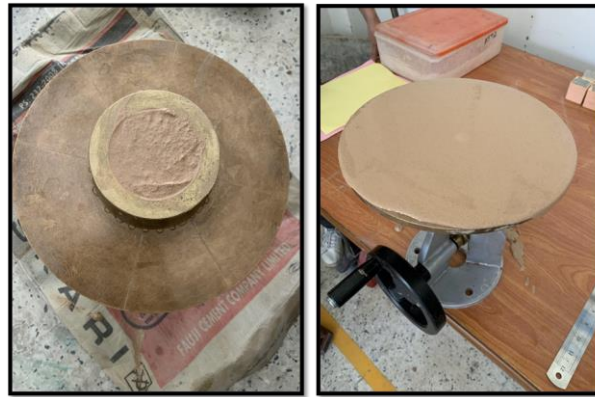
The flow table test is shown in Figure 6. The flow exceeded the limits of the flow table, as illustrated in the Figure. This indicates that the material exhibited high workability (while maintaining an excellent cohesion), which prevented the measurement of a flow diameter.

Figure 6: Flow Table test

In the flow table test, the mortar mixes were filled in two layers in a cone as shown in Figure 6. After compacting with a rod, the cone was lifted and after raising and dropping the table 15 times, the final diameter of the mix was measured. The density was determined by measuring the mass and volume of the specimen and by using the equation (1):
